Morphology of Surface Integrity as Effect of Cold Forging of Aluminum Alloy

Morphology of surface integrity as effect of cold forging of aluminum alloy

Keywords: aluminum alloy; cold forging; wear characteristics; FEM

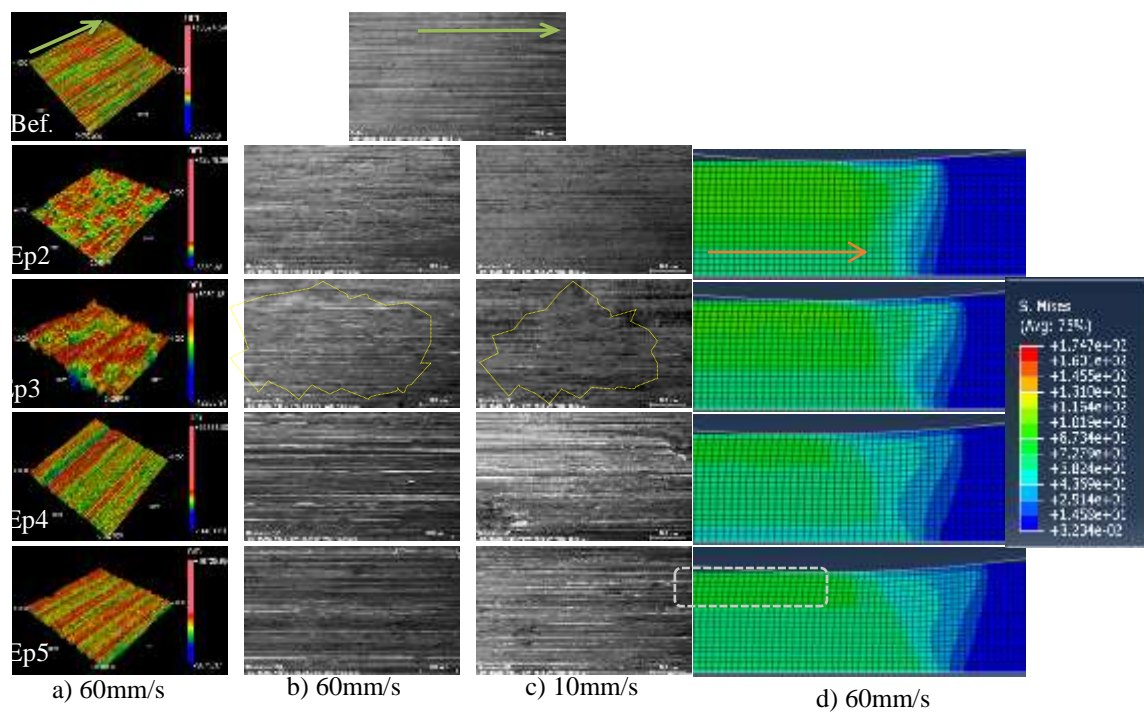
Figure 8. Effect of cold forging of aluminum alloy on the surface integrity

The process of damage occurring on the tool surface may strongly affect the surface integrity of the workpiece surface. As long as the degradation of tool surface occurs, and the thickness of material deposition grows (as a proportion of plastic strain) on the top of the tool surface, the machined surface appears to become more and more degraded, showing visible craters and cracks. A consistent relationship between tool damage and workpiece integrity has been established, as emphasized in Figure 8.

The results acquired by 3D-optical profilometry, in Figure 8 a), show a map with the evolution of workpiece surface while the plastic strain increases. It seems that at low plastic strain (Ep1-Ep2) the macroscopic modification on the workpiece surface produces an isotropic structure that presents the same stature in all directions, especially for low speed. However, when the strain increases to Ep5 the orthotropic modification on the workpiece surface appears, as tool degradation evolves while increasing the material transfer, as per Ep3 to Ep5. The change in the machining speed may accelerate further the progress of surface degradation, as can be observed in Figure 8b) in respect to Figure 8c). The SEM observations permit a better interpretation of the structure morphology achieved by profilometry measurements. When the imposed penetration develops a range of plastic deformation that covers the Ep1-Ep2 interval, the workpiece surface processed presents homogenous morphology with a low value of roughness. However, the rough pitch rises in the Ep3 interval (see Figure 8a, b, and c for Ep3). The workpiece surface behaves almost orthotropically with a significant number of peaks and shallow valleys in the Ep4-Ep5 interval. The numerical simulation (in Figure 8d) provides insight as to how plastic deformation acts inside of the workpiece structure that is of vital importance to understand the evolution of surface integrity. The numerical model reveals that at low plastic strain, from Ep1 to Ep2 interval, a homogeneous material behavior occurs over the entire workpiece depth that means this loading produces only superficial modification of the workpiece surface. However, when the loading increases, the stresses tend to accentuate near the interface when the value of Ep reaches

the grade Ep5; the contact generates large deformation at the interface between tool and workpiece and the sticking mechanism is very unpredictable, creating an orthotropic surface. Corroborating the numerical simulation with the profilometry measures and SEM observations permits the validation of the numerical tool as a design solution to predict the surface integrity of the workpiece and thus predict with accuracy when the tool needs replacement.
